Manhole Inspection Summary

Manhole # S25M__031MH

Inspection ☐ Is Incomplete Rating: **4) Poor**

Location Address: **1210 Washington BLVD**

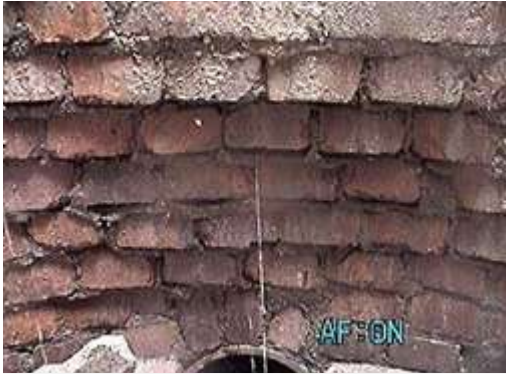
Defect 3

Infiltration: ☐ None ☐ Joint ☐ Cracks ☐ Mortar ☐ Roots ☒ **Wall**

infiltration on the corbel & barrel walls

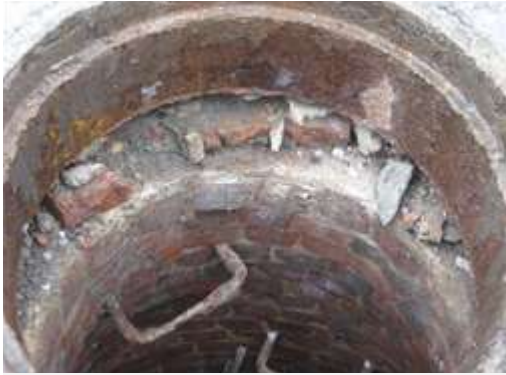
Defect 2

Condition: ☐ Sound ☐ Cracked ☐ Root Intrusion ☒ **Loose Brick** ☐ Deteriorated

Broken loose and missing bricks and mortar in chimney with signs of infiltration

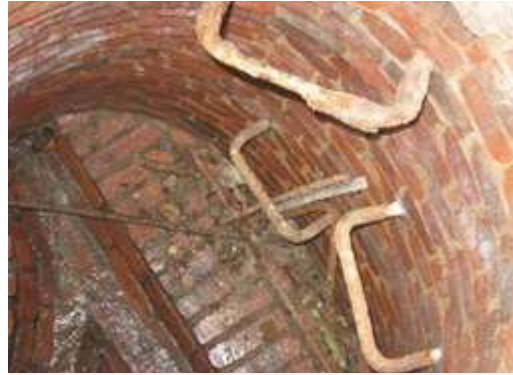
Defect 1

Steps Count: **3** Missing: **0** ☒ **Corroded**

corroded steps

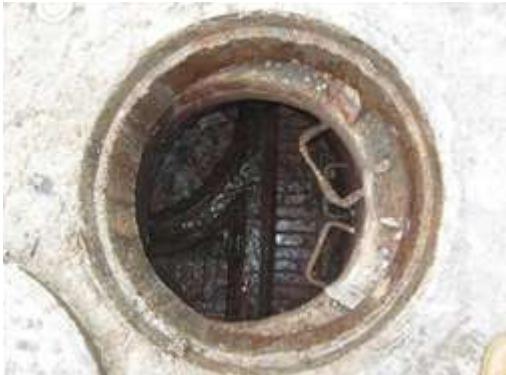
Defect 4

Frame Offset: **4** (in.) Condition: ☒ Sound ☐ Cracked ☐ Leaks

frame offset

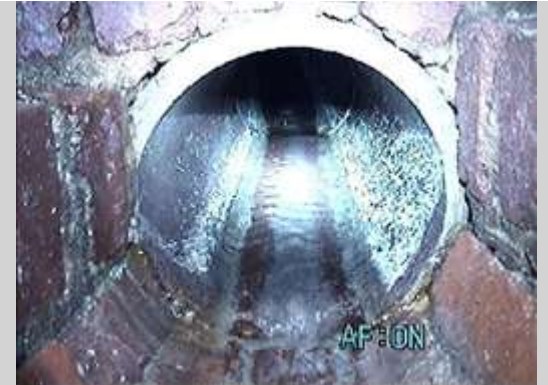
12 O'Clock Outflow

Pipe Height: **8.4** (in.) Rod and Bar (Angled)
Pipe Material: **Clay** ☐ Pipe Lined
Invert Depth: **6.69** (ft.) Flow Characteristics: **Slow**
Deposits: ☒ None ☐ Mud ☐ Sludge ☐ Debris ☐ Grease
Silt Depth: **0** (in.) Deposits Extent:
Infiltration: **Evidence** Pipe Seal Cond: **Unknown**

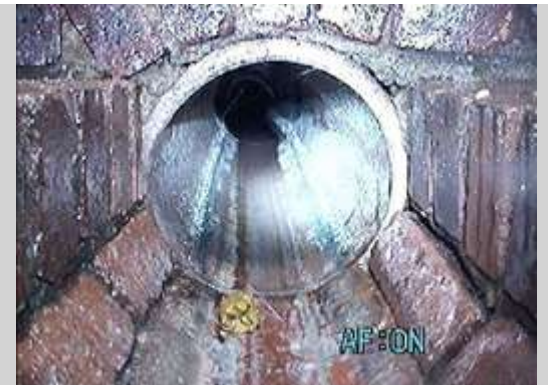
6 O'Clock Inflow

Pipe Height: **8.4** (in.) Rod and Bar (Angled)
Pipe Material: **Clay** ☐ Pipe Lined
Invert Depth: **6.61** (ft.) Flow Characteristics: **Slow**
Deposits: ☒ None ☐ Mud ☐ Sludge ☐ Debris ☐ Grease
Silt Depth: **0** (in.) Deposits Extent:
Infiltration: **Evidence** Pipe Seal Cond: **Unknown**

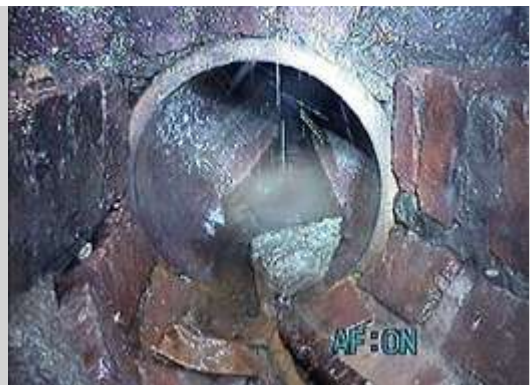
9 O'Clock Inflow

Infiltration: **Evidence** Pipe Seal Cond: **Unknown**
